Underground mine tunnels of the Terezín fortress — history, functions, problems

Underground mine tunnels of the Terezín fortress – history, functions, problems

Mgr. Jiří Hofman, Ph.D. (1983)

Ing. arch. Lukáš Hudák (1984)

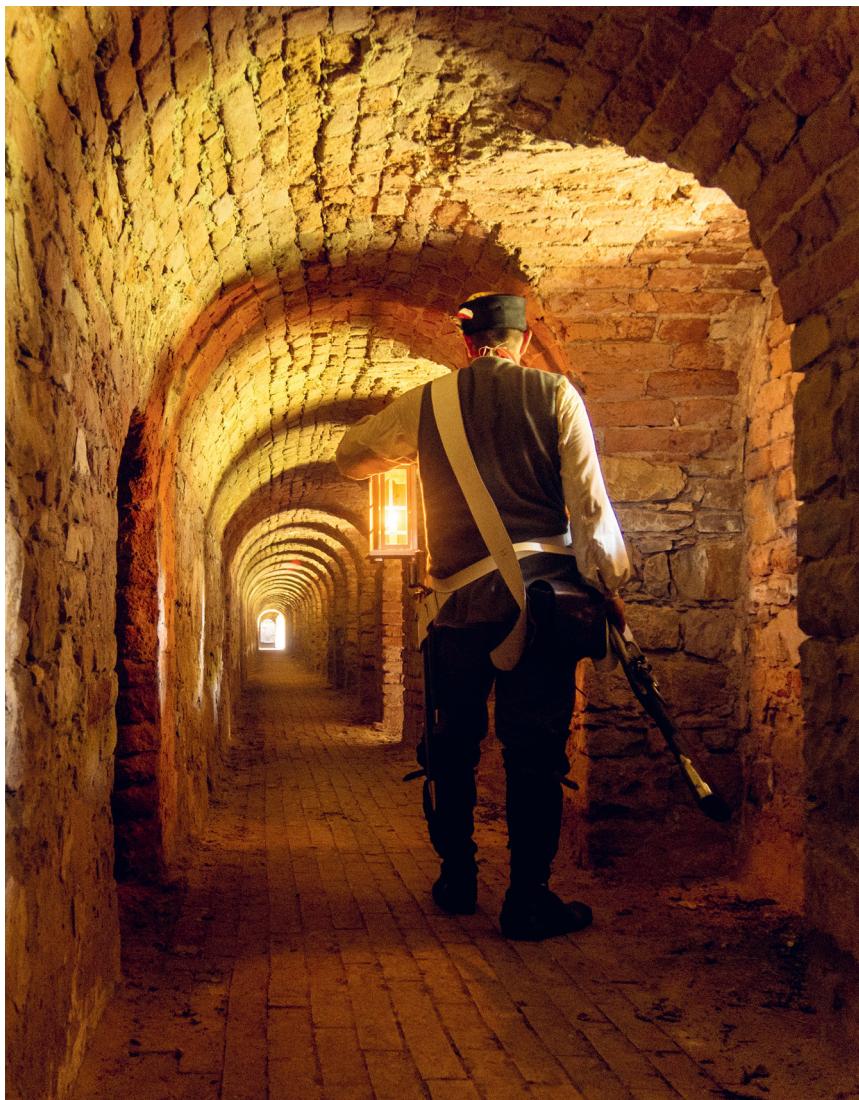
Perspective view of the main gallery.
(J. Formánková Hofmanová).

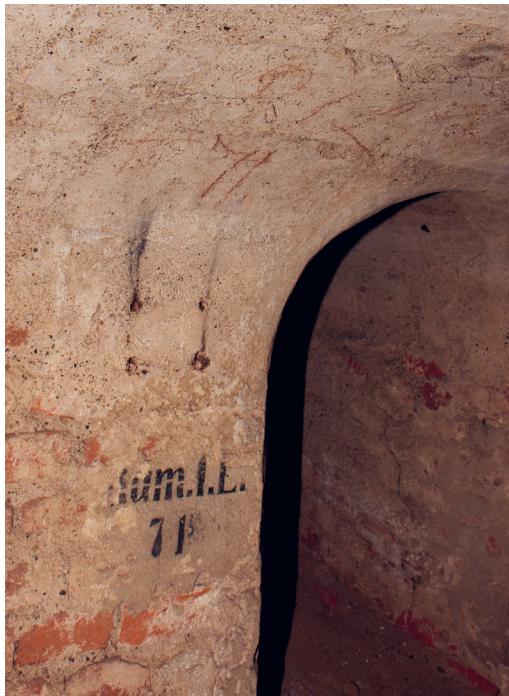
Various historical phases of the markings for the entrance to level 1 mine branches No. 71. (J. Hofman).

Orientation in the above spaces was facilitated by the generally clear layout of the corridors and their numerical designation based on the above terminology. Essentially all underground structures have their own autonomous numbering — underground entrances, gunpowder depots, level 1 and 2 mine branches, traverses, listening galleries, places-of-arms, retrenchments. According to preserved inscriptions, the niches were also marked with numbers, and even doors to retrenchments and places-of-arms had their own numbers. E.g. 'Ram.1.L.71' means level 1 mine branch number 71, 'Pld'a N. 40' is place-of-arms number 40, etc.

Because all mines were originally (and to a large extent still are) plastered, way back the numbers were only drawn manually with ochre clay on the surface. A more recent method seems to be black inscriptions over a stencil, and the most recent method are probably metal plates, which have, however, not been preserved in their entirety.

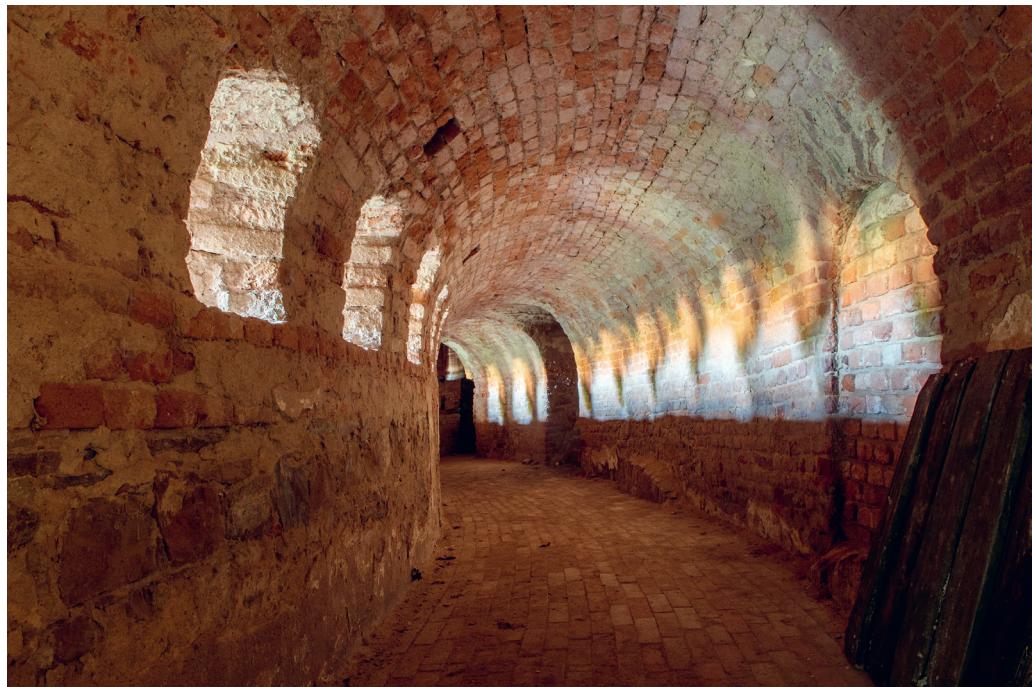
Interior view of the casemate within the main gallery. (J. Formánková Hofmanová).

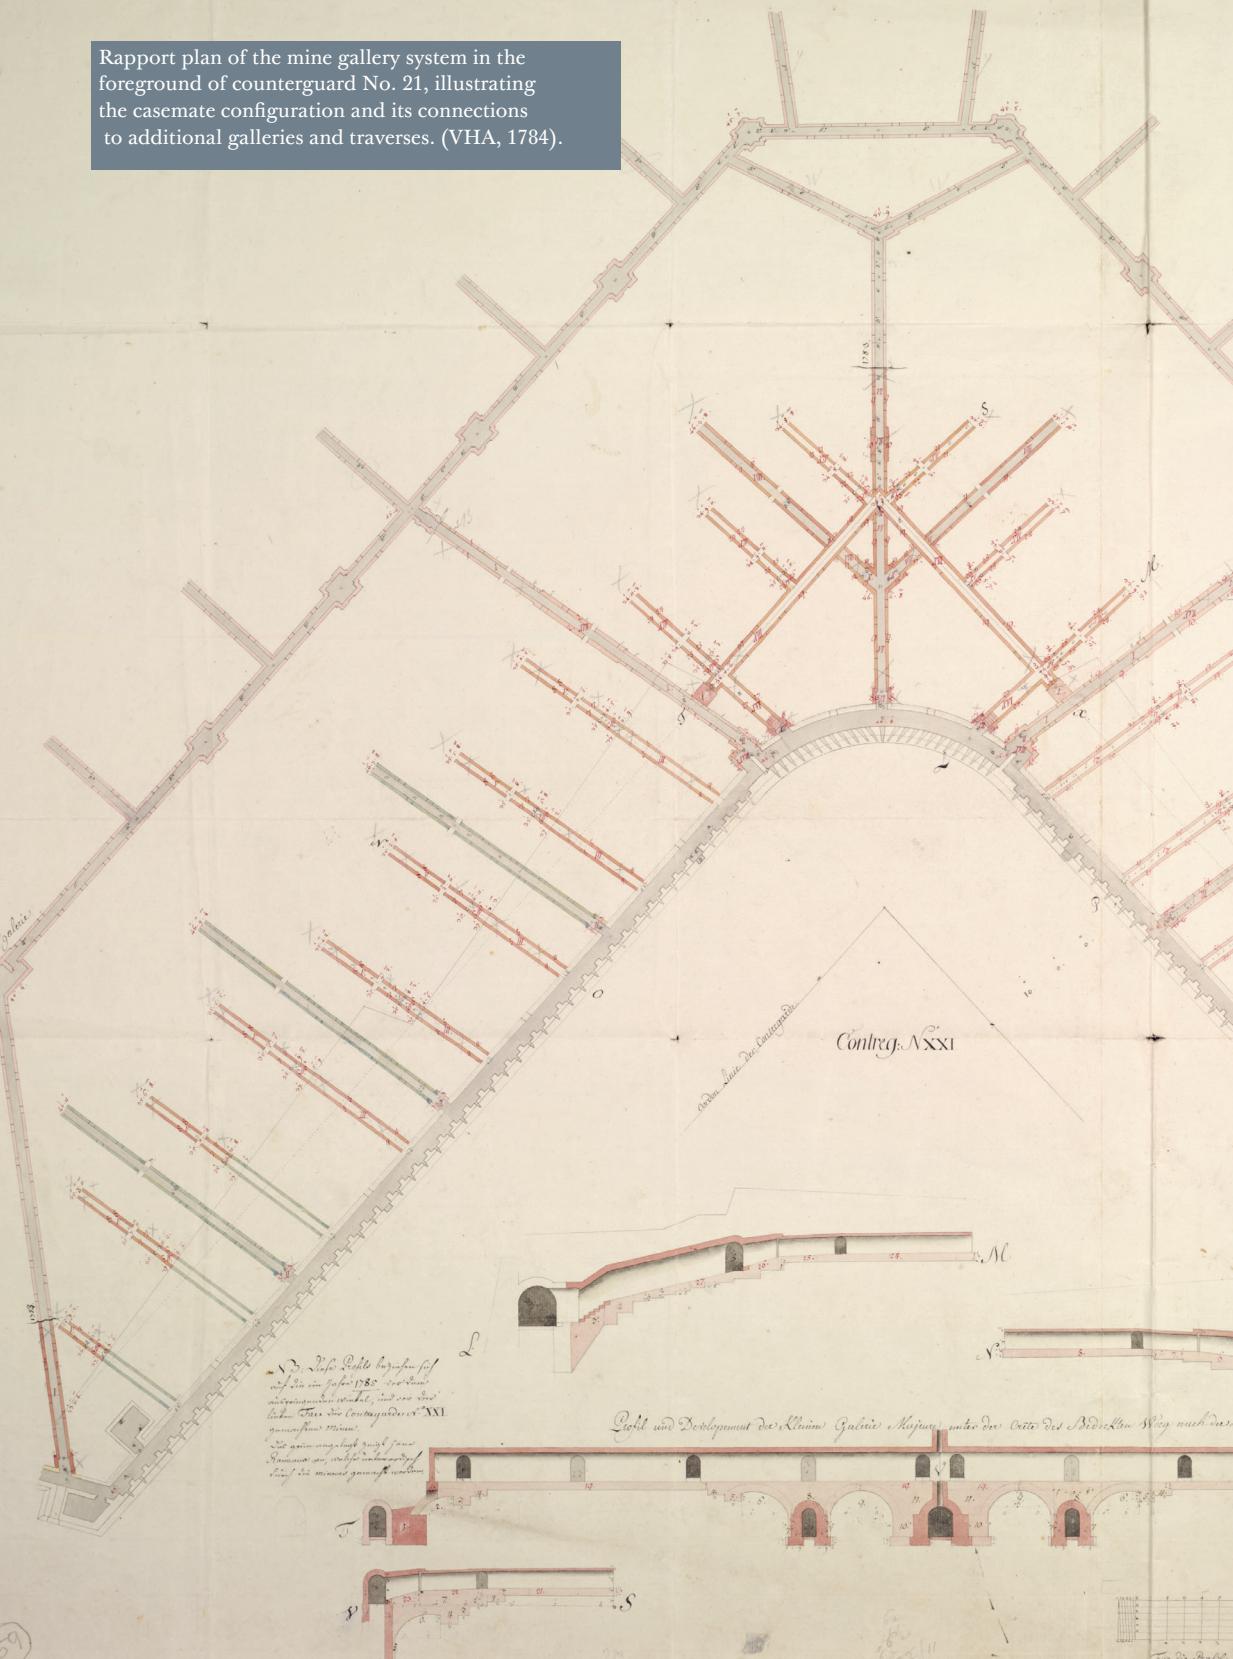
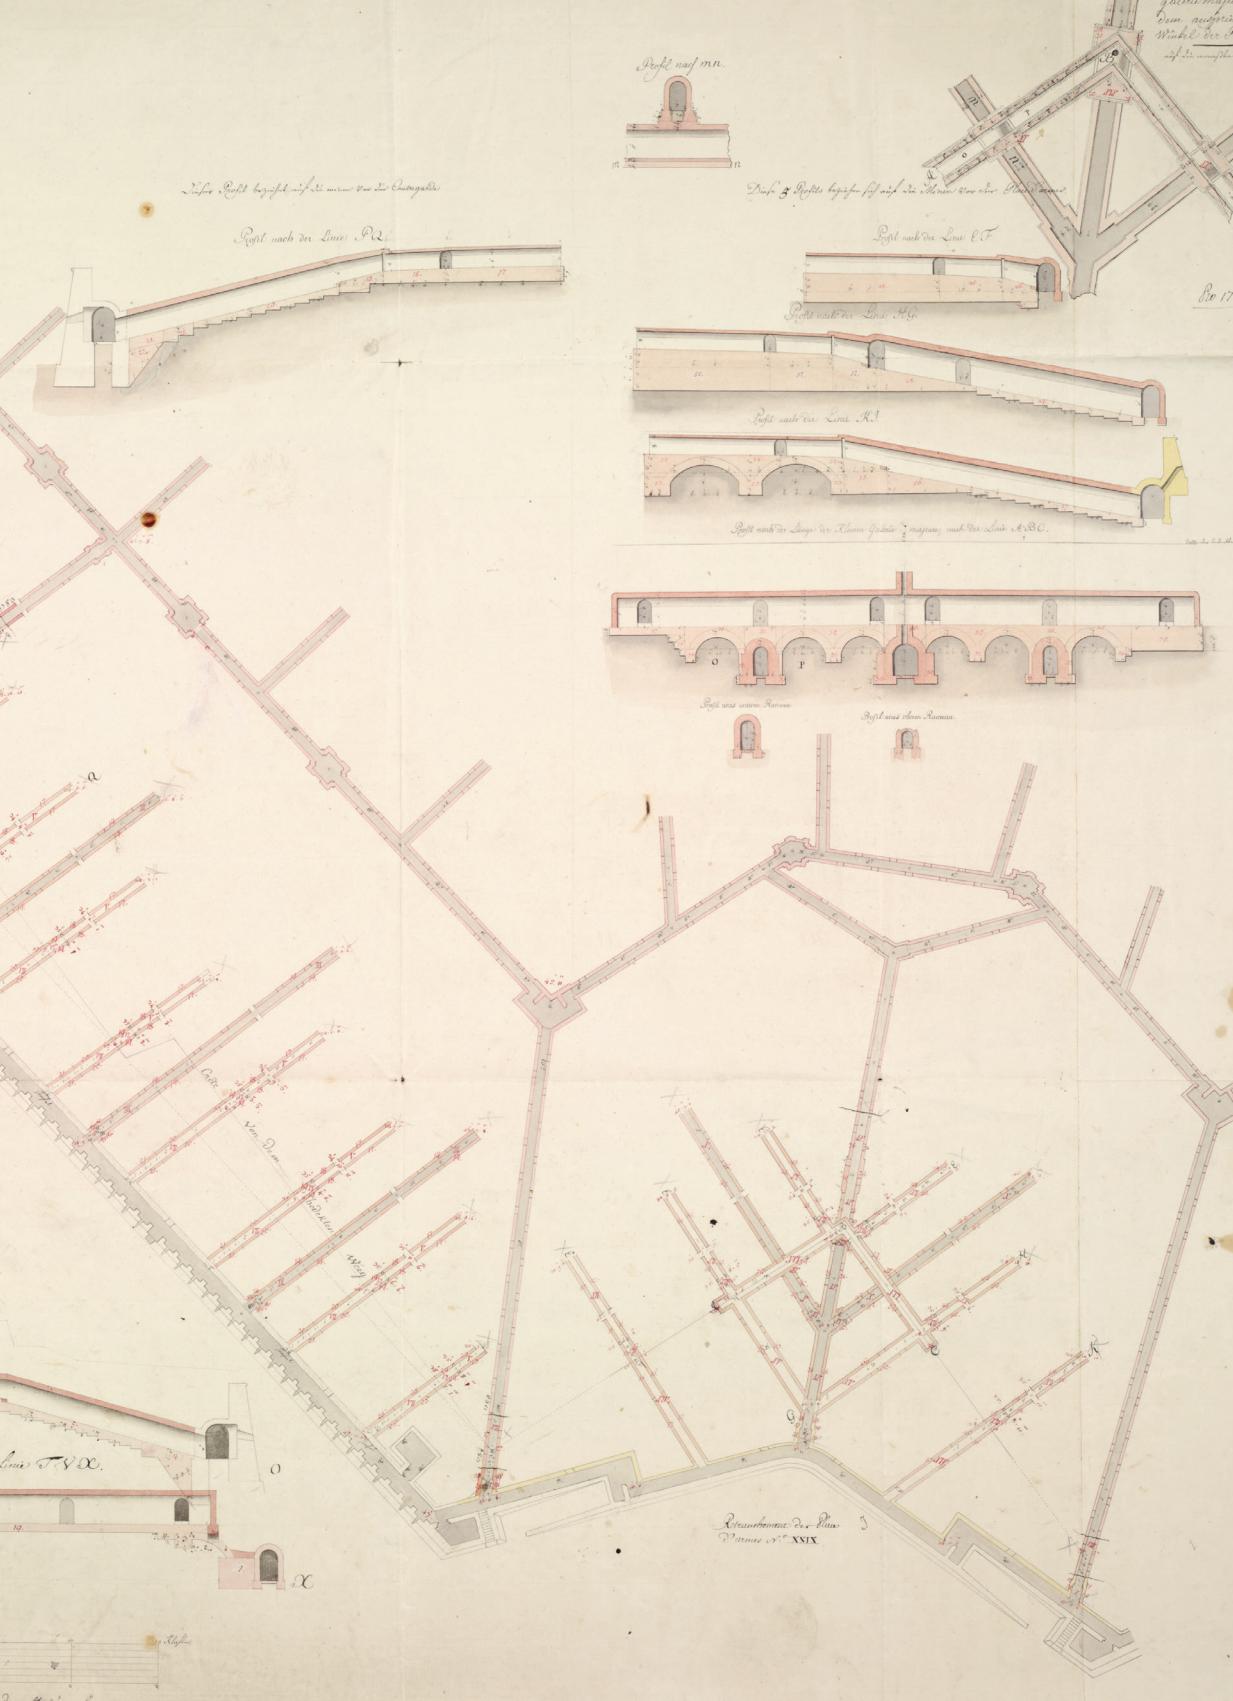
Rapport plan of the mine gallery system in the foreground of counterguard No. 21, illustrating the casemate configuration and its connections to additional galleries and traverses. (VHA, 1784).

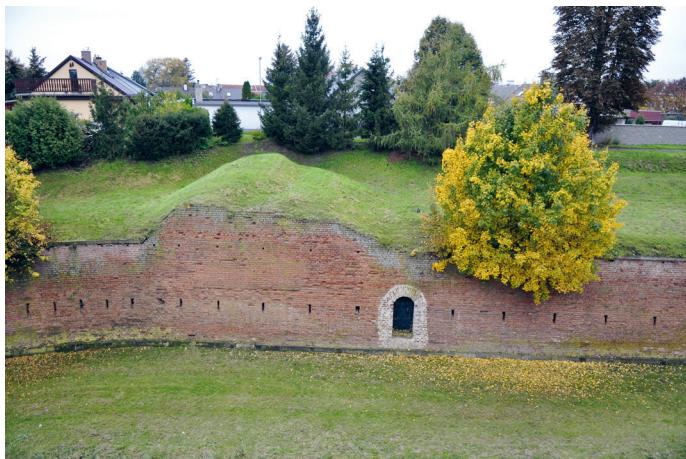
Main gallery entrances from the moat. (L. Hudák).

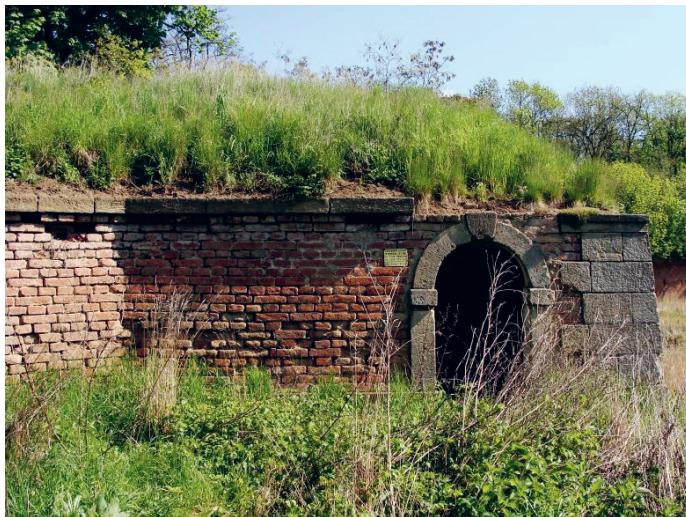
Main gallery entrances from the area
of the lunettes. (R. Gazsi).

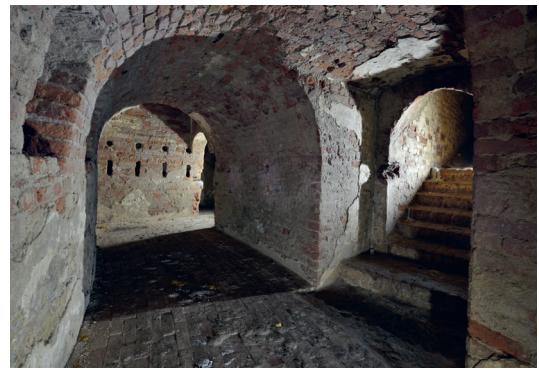
Traverse within the main gallery, view from the casemate; to the right, the entrance to the upper gallery. (J. Formánková Hofmanová).

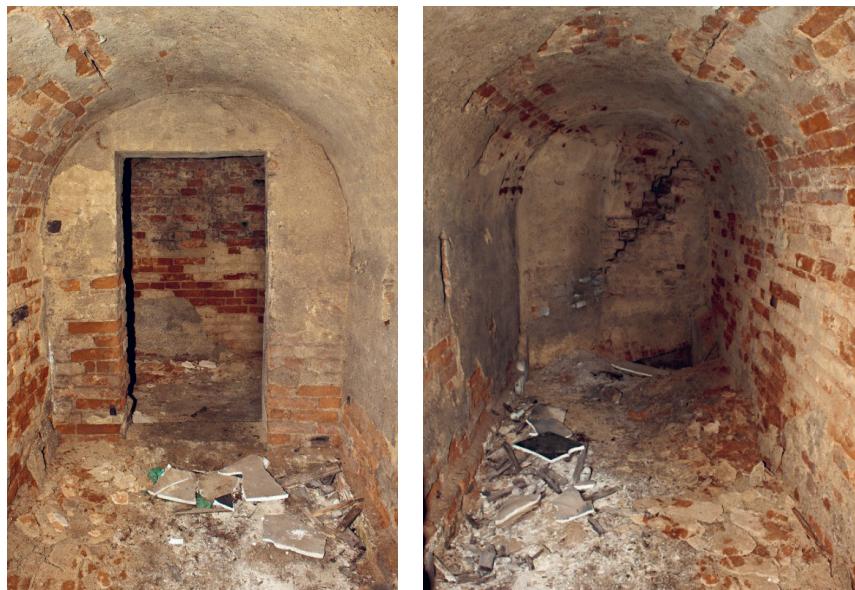
Photograph of a hand-powder magazine.
(R. Gazsi).

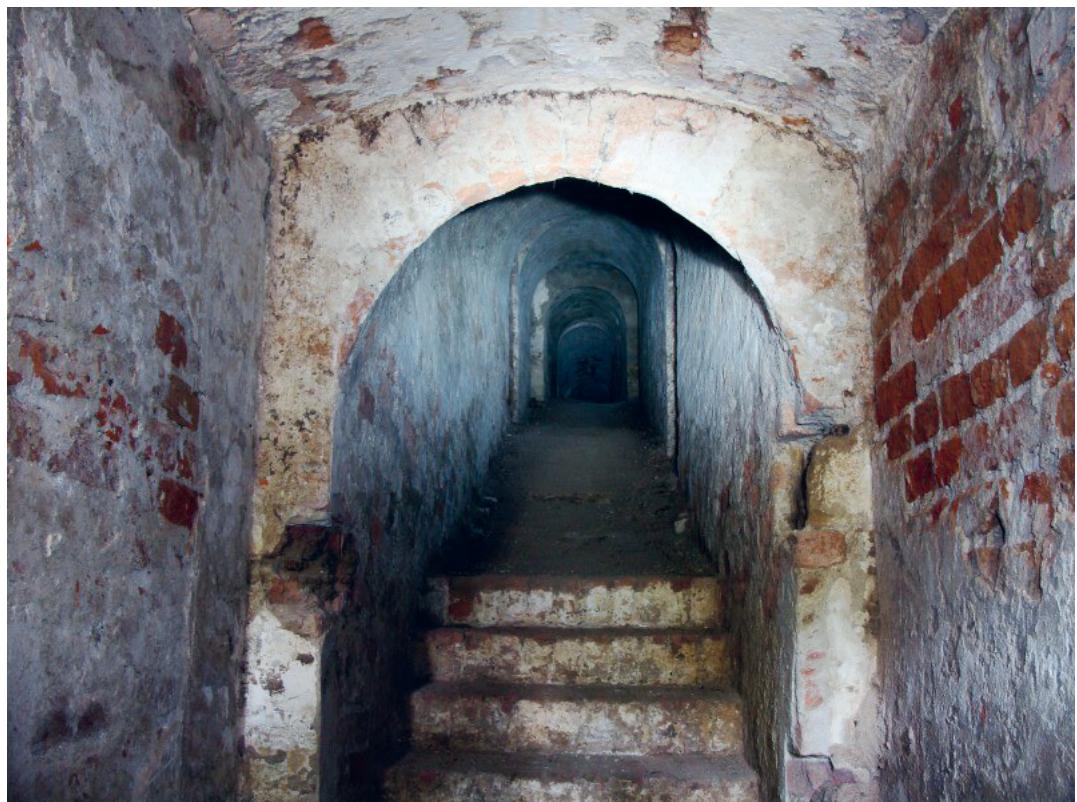
Entrance to the upper gallery, the so-called Galerie Supérieur. (R. Gazsi).

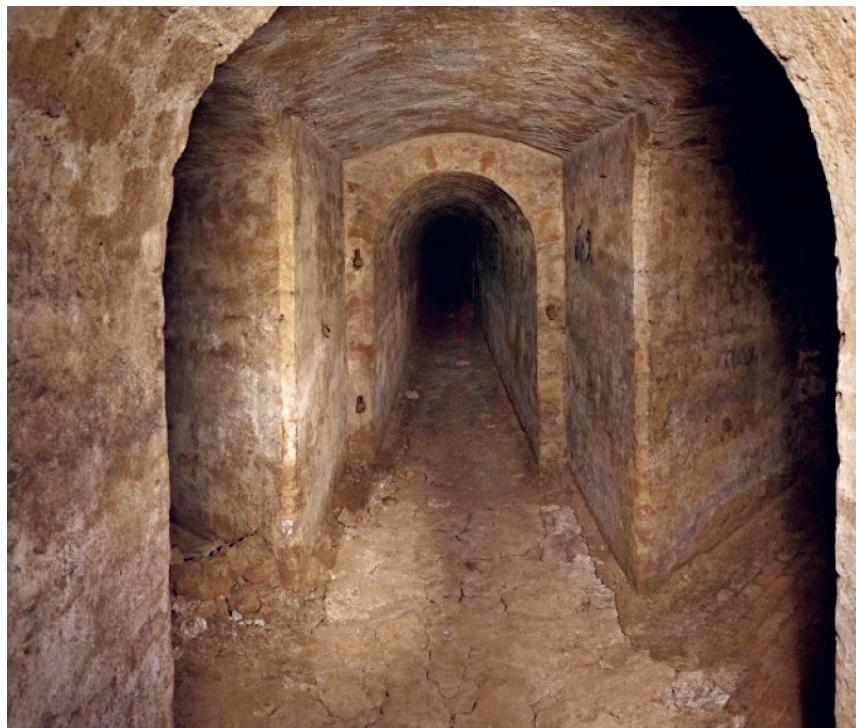
Interior view of the communication gallery featuring entrances to the upper gallery in front of the lunettes. (R. Gazsi).

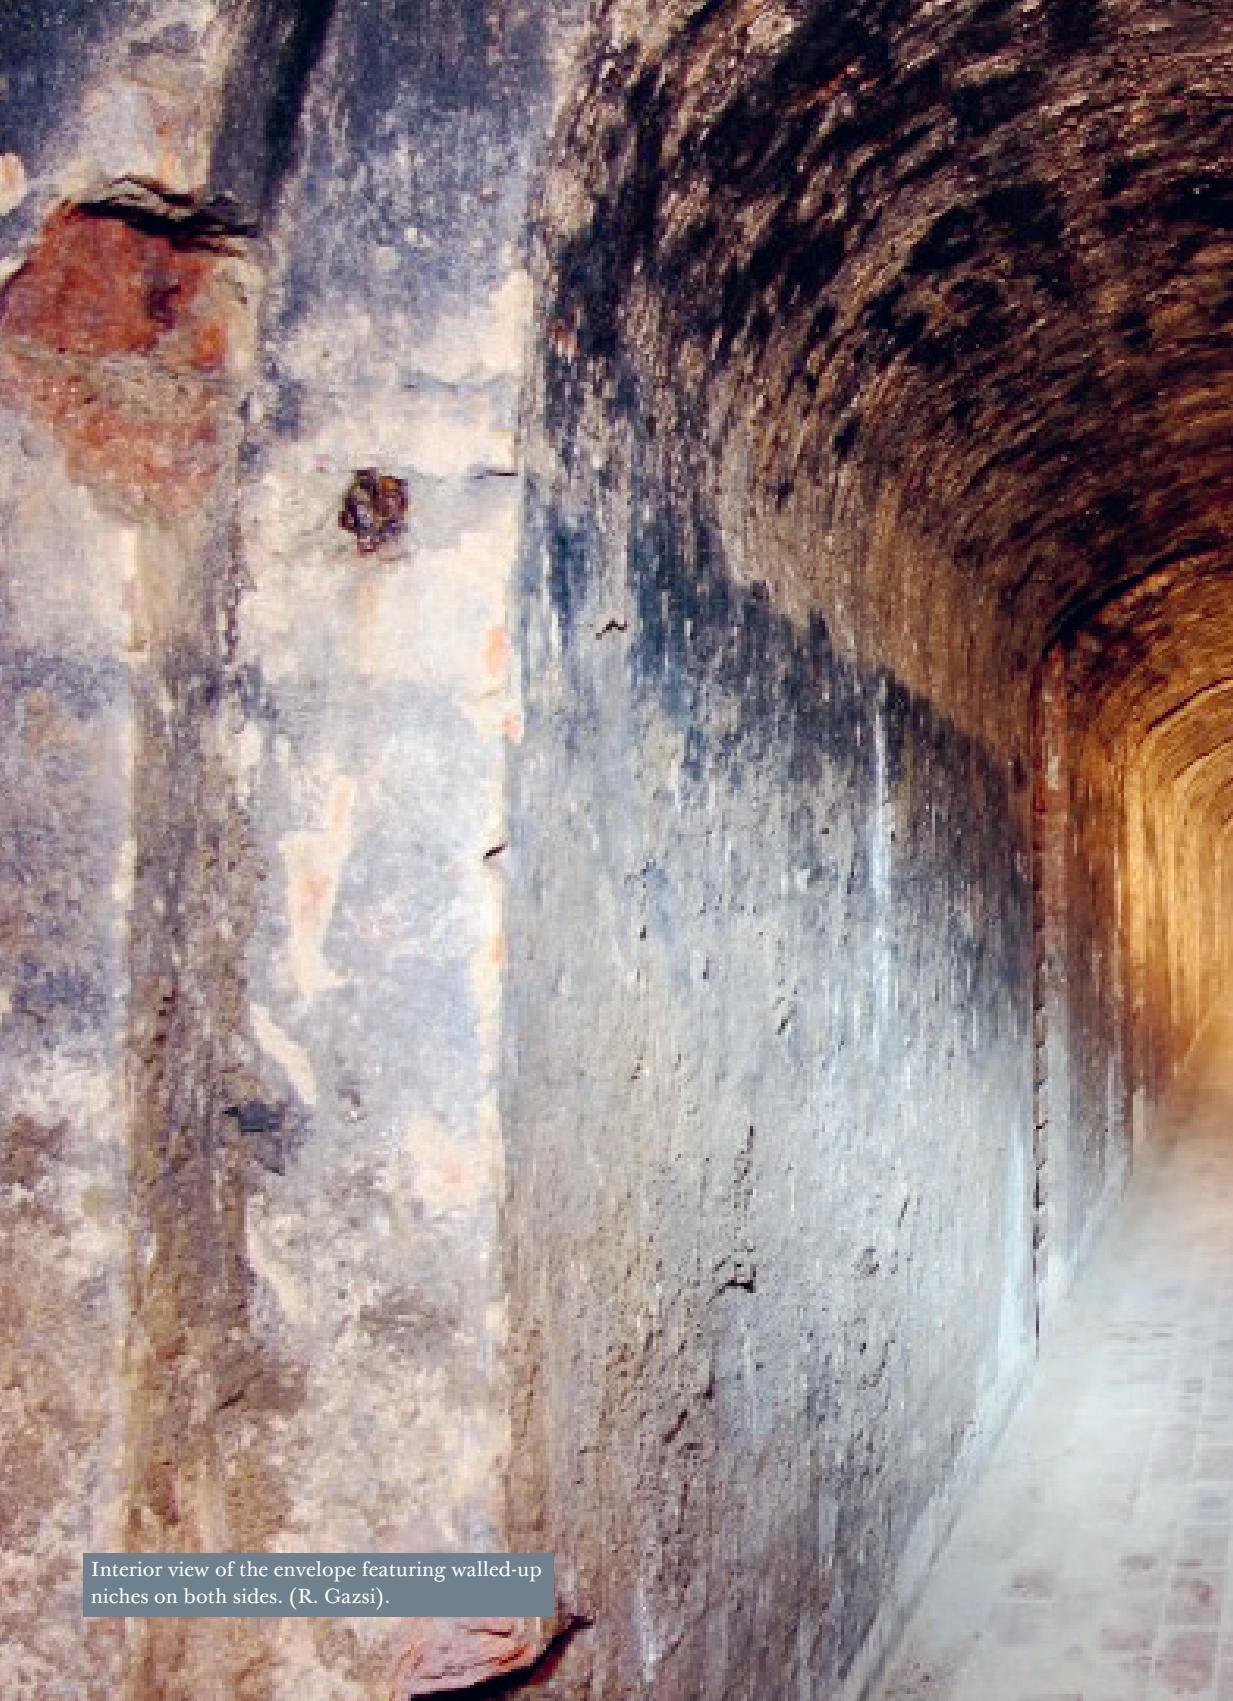
Interior view of the envelope featuring walled-up niches on both sides. (R. Gazsi).

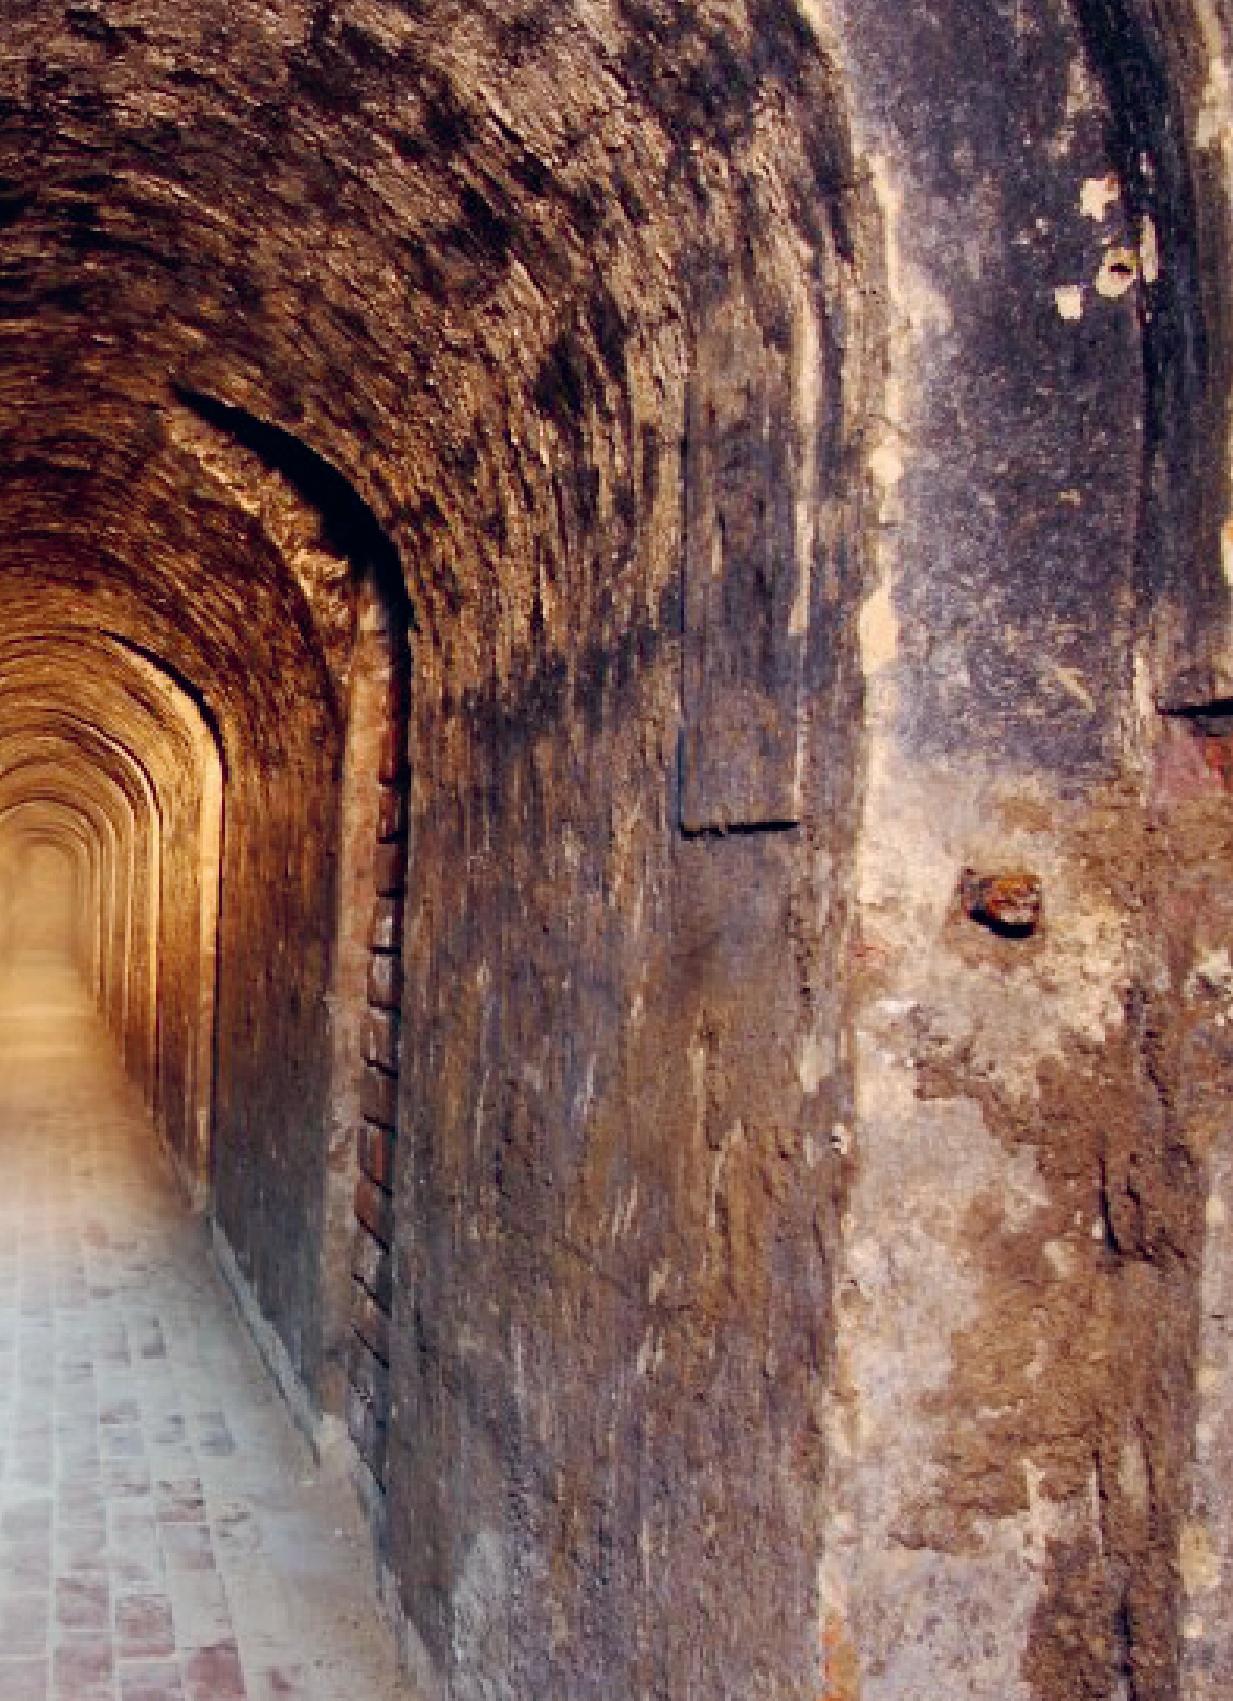
View of the inclined section of the **level 1 mine branches** featuring slots for timber beam insertion. (SPELEO – Řehák).

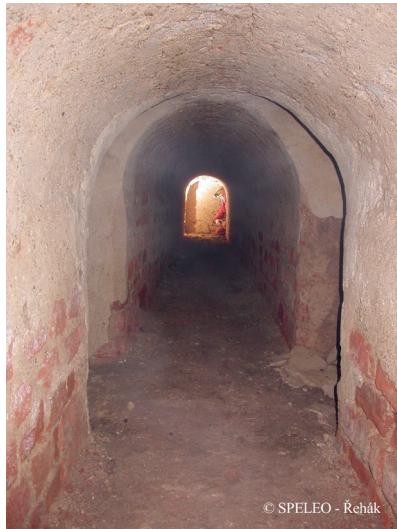
Interior view of the **level 1 mine branches** gallery at its face. (SPELEO – Řehák).

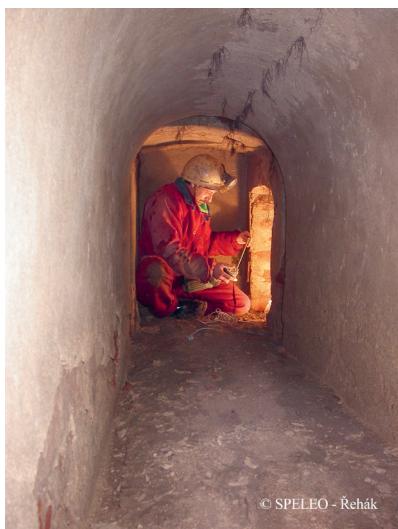
Interior view of the **level 1 mine branches** in front of the mouth of the mine chamber. (SPELEO – Řehák).

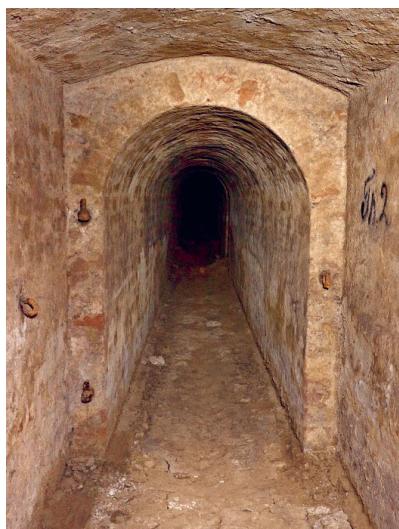
Interior view of the entrance to the **level 2 mine branches**. (SPELEO – Řehák).

At the level of the main gallery, the **level 2 mine branches** (e.g. ‘*Rameaux 2. Laage*’) extend into the forefield, which are 81.2 cm wide and 162.5 cm high along the entire length of the profile. These are also sloped slightly towards the side of the trench to ensure drainage of seeping moisture. All these tunnels naturally contain the aforementioned niches and, in appropriate sections, also grooves (e.g. ‘*Coulisses*’).

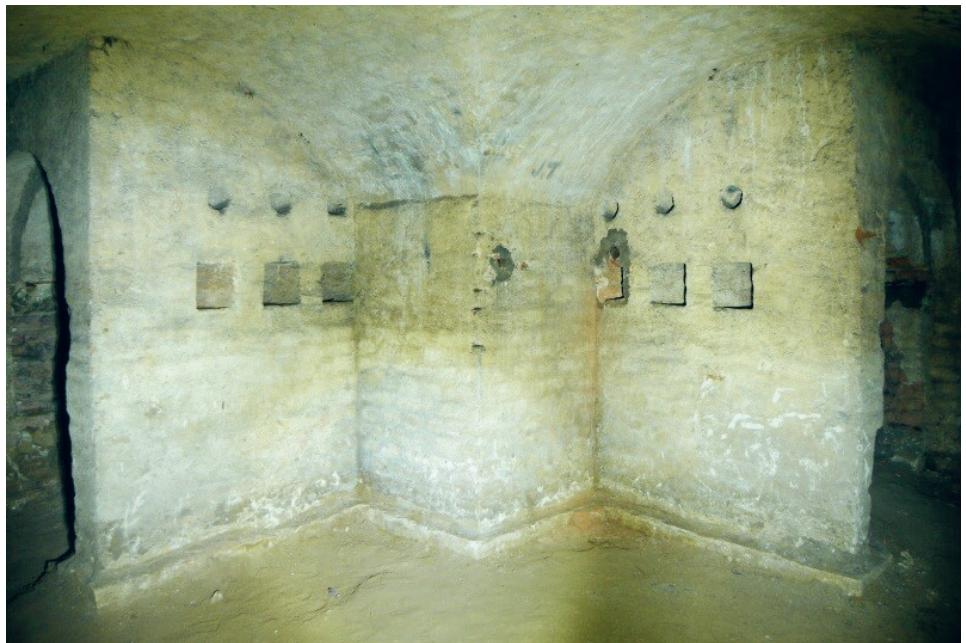
Interior view of the tambours featuring traverses and entrances to the envelope. (R. Gazsi).

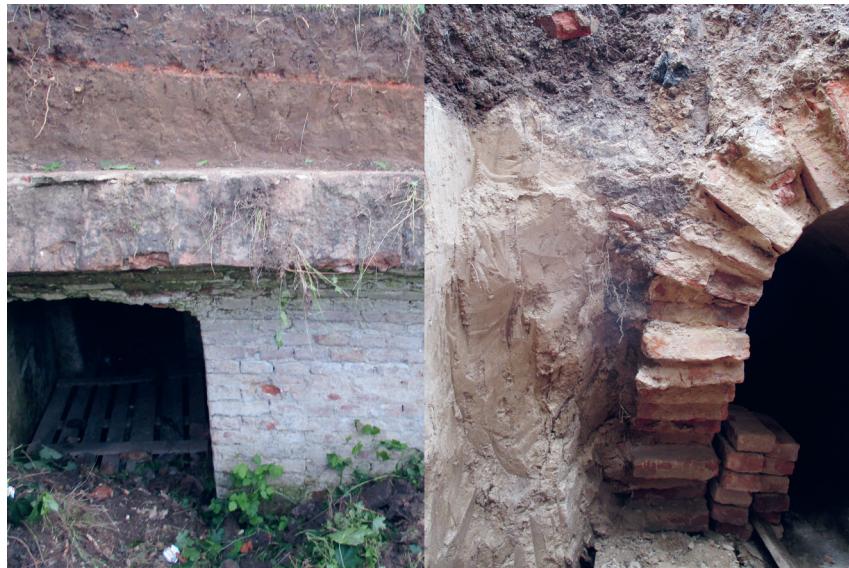
Left: Individual layers of backfill above the vault of the main gallery in front of bastion No. 4 during the 2016 repairs. Right: The visible distinction between the original ground level and the subsequent backfill of a **level 1 mine branches** in front of ravelin No. 18. (Jiří Hofman).

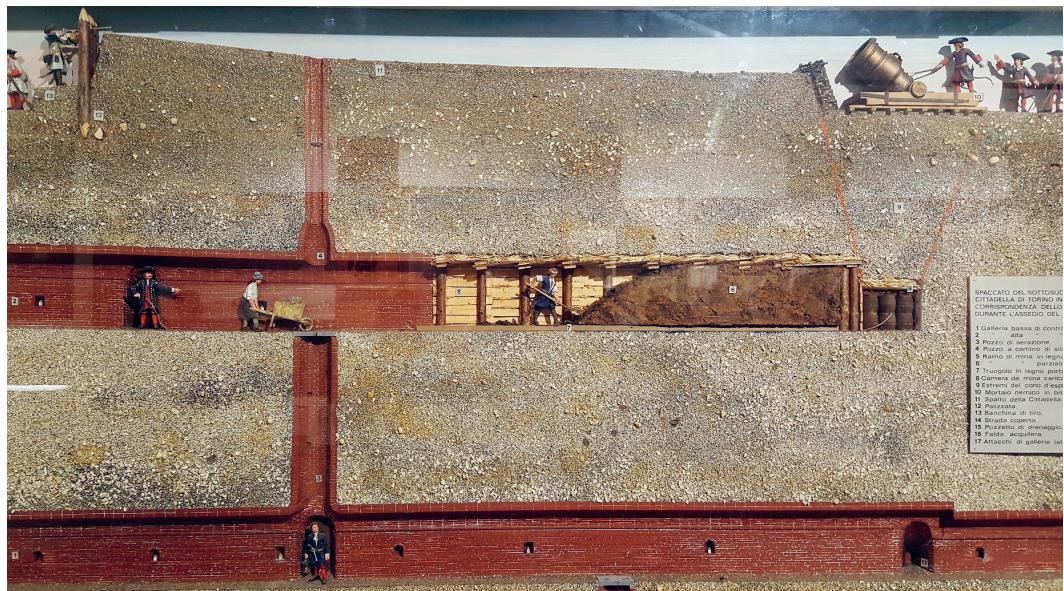
The model illustrates a charged mine chamber (fourneau) positioned beneath the opposing mortar battery. (Museo Civico Pietro Micca e dell'Assedio di Torino del 1706).

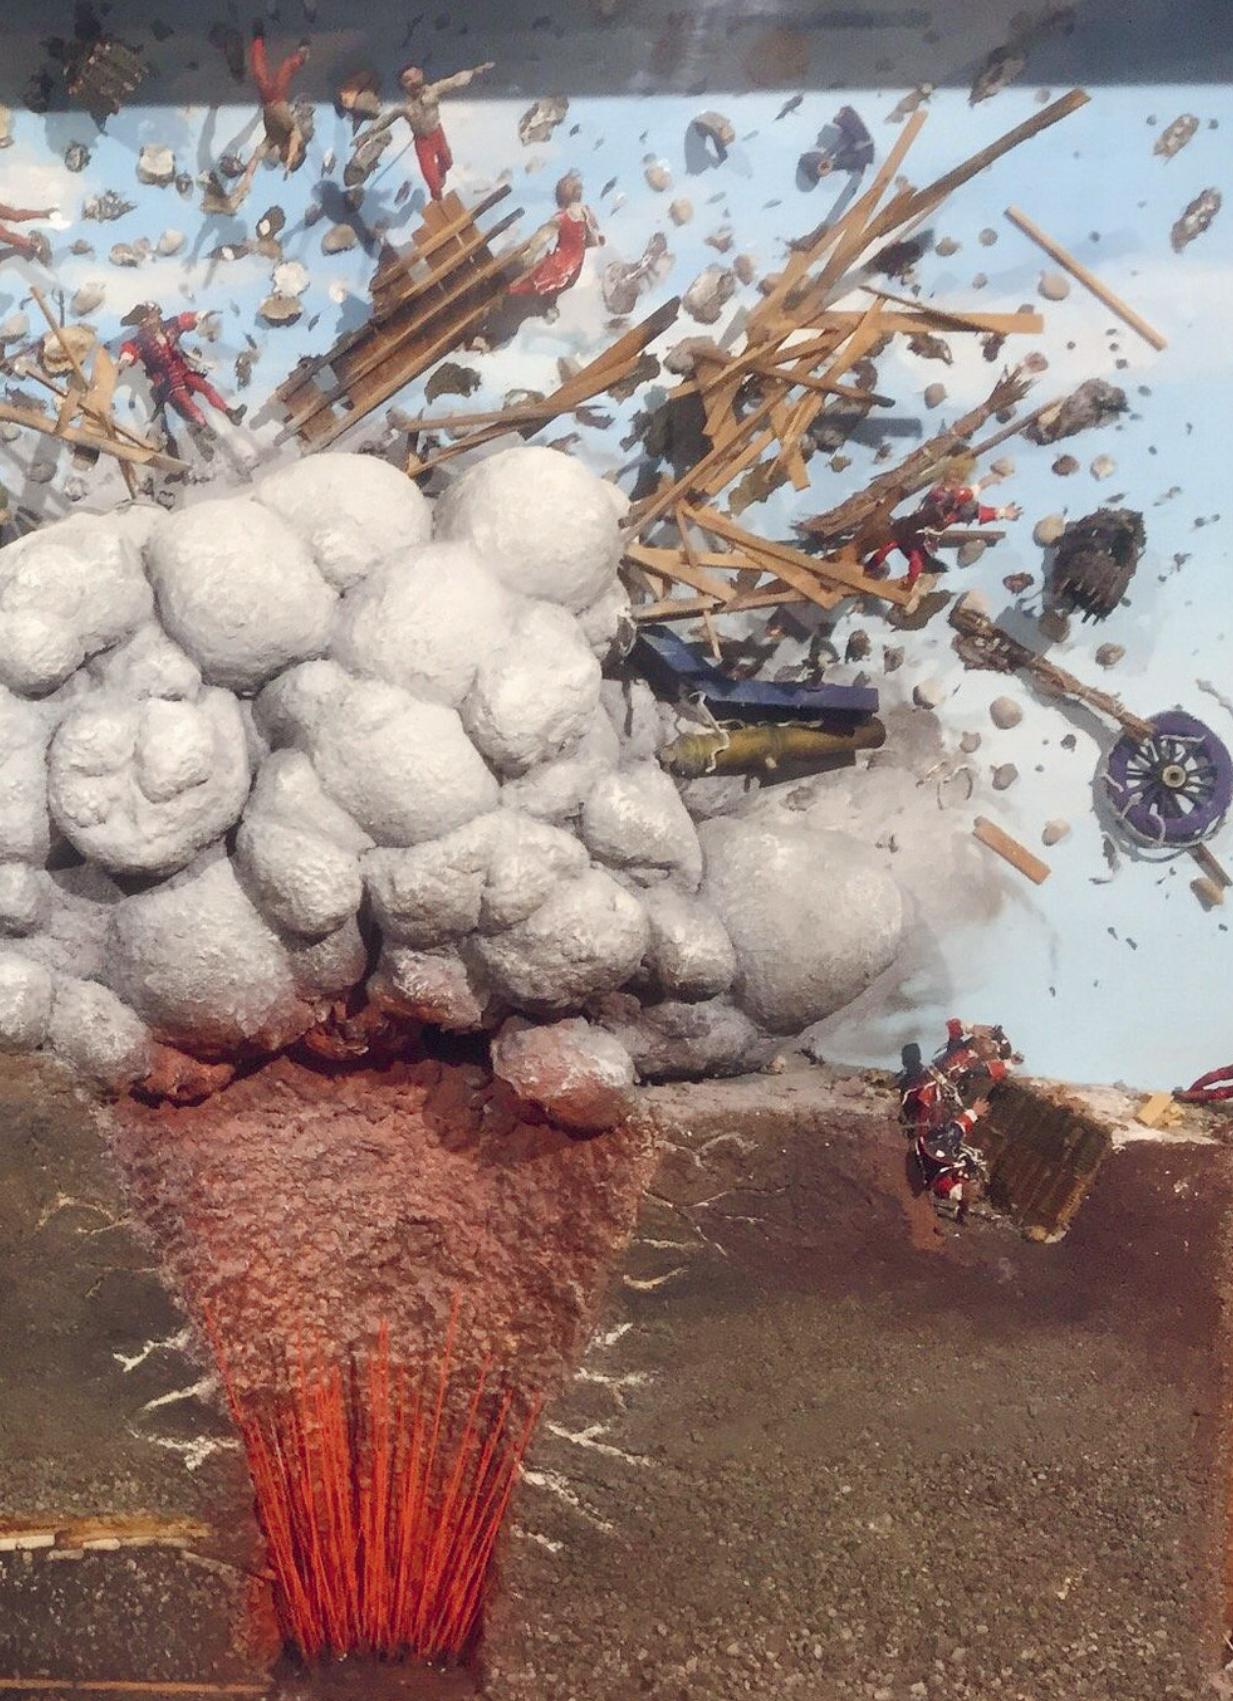
The model illustrates a detonated mine chamber disabling a mortar battery. (Museo Civico Pietro Micca e dell'Assedio di Torino del 1706).

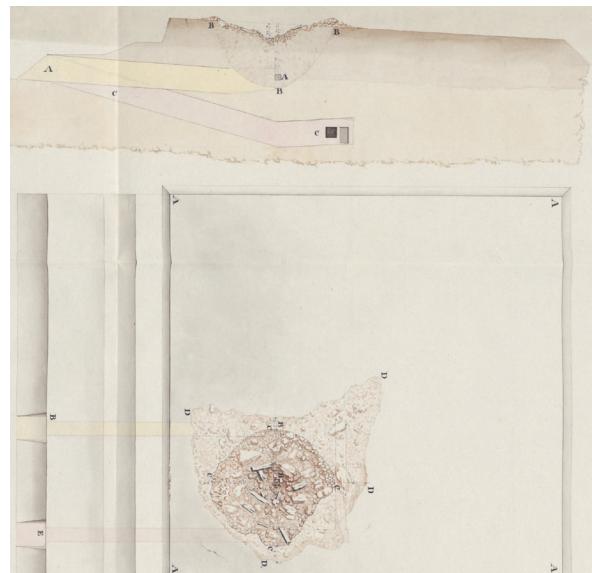
Plan of the 1787 mine experiments in Terezín,
illustrating the results of **level 1 and 2 mine branches**
detonations (Österreichische Nationalbibliothek).

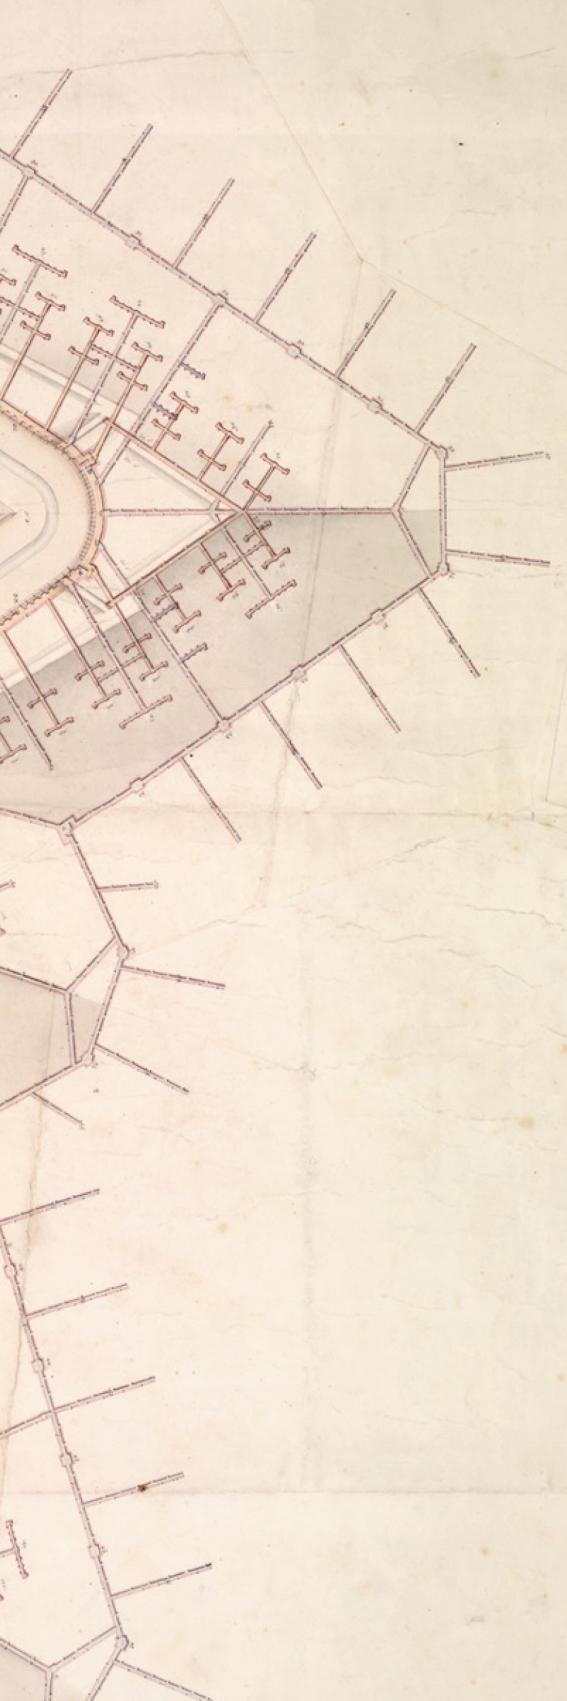
The structural evolution of the Terezín fortress mine system – left: the earliest phase; center: expansion during the early 19th century; right: an unrealized proposal to supplement the listening galleries with mine branches (VHA).

- The oldest version of the mine system did not remain unchanged for long. Sometime before 1809, the listening galleries were extended and the mine tunnels of the Main Fortress were branched. This is how the Terezín underground was shaped into its current form. We don't know much about this work, we only know that it happened. The corridors were extended through mining with timbering, into which the brick structure of the mine was built. Even today, we can easily identify the extensions of the listening gallery; there are no protruding foundation walls and they are only covered with one layer of plaster (older corridors have a double layer). The transition between older and newer plaster is clearly visible in many places. In the years 1809 to 1810, work must have already been underway, because we have a record of the brickwork of listening gallery No. 47, while other work was to be stopped for the time being due to a lack of funds.⁷⁵ In the following year of 1811, these activities were completely stopped for the same reason.⁷⁶ There is a mention of captain Franz Würth von Hartmühl in 1812, who had already participated in experimental explosions with Březina as a 'Jung-Mineur' in 1787 and had now returned to Terezín.⁷⁷ His obituary says the following: *'In 1812 he was appointed captain and received the order to add missing branches to the Terezín mine system (e.g. 'Wendungen' — author's note). He had only 140 men, miners, at his disposal, 74 of whom were recruits. Nevertheless, with unprecedented diligence and endless effort, he managed to complete the mining in an even shorter than expected time of 3 months. In a length of 1,800 fathoms, in the sandy subsoil, he proceeded by mining with timbering, which was later bricked up.'*⁷⁸ However, there is also a record in literature for years 1814-15 'according to the plan submitted by mining captain Schirr, the mine corridors that were currently supported by timbering were bricked up.' This completion of the mine system therefore lasted at least from 1809 till 1815. The author of the project was most likely captain

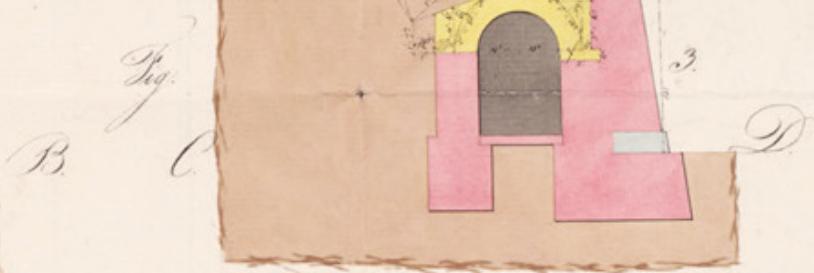
Repair of the main gallery in front of ravelin
No. 7 of the Small Fortress in 1830. (VHA).

main gallery before the left face of ravelin No. 7 and bastion No. 2.⁸⁵ Then repairs moved back to the Main Fortress. Between 1832 and 1835, it was necessary to repair and rebuild level 1 mine branches No. 4, 15, 17, 21, 25, 31, 34, 36, 69, 74, 75, 76, 79, 87, 94, 101, 103, 119, 122, 124, upper gallery No. 3 and listening galleries No. 10, 12, 18, 21, 32.⁸⁶ As this rather dry list of tunnels shows, the extent of the damage was indeed considerable. Many parts of the system also had to be rebuilt for the third time.

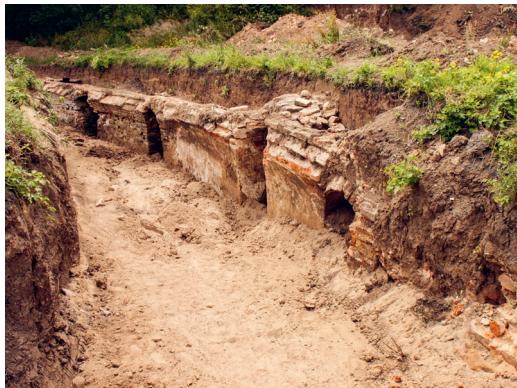
Following modern floods, several galleries collapsed and were slated for reconstruction. These incidents have provided valuable insights into the original construction principles, stratigraphy, and building techniques. This section illustrates both the construction and repair process via open-cut excavation. Repair of the collapsed main gallery following the 2013 floods using surface excavation (J. Hofman).

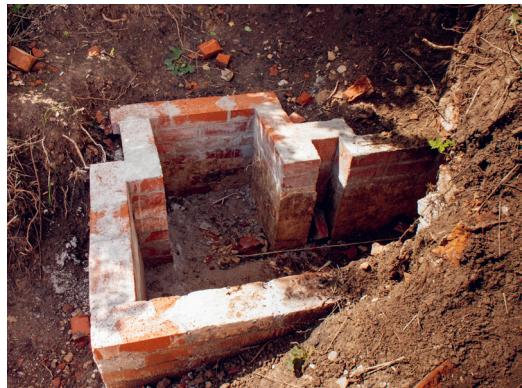
Restoration of a **level 1 mine branches** during repairs following the 2013 flood (J. Hofman).

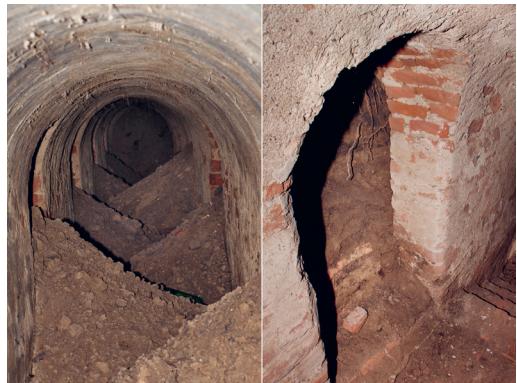
Surrounding soil collapsed through the missing masonry infills of the recesses into the mine galleries during the 2013 floods (R. Gazsi).

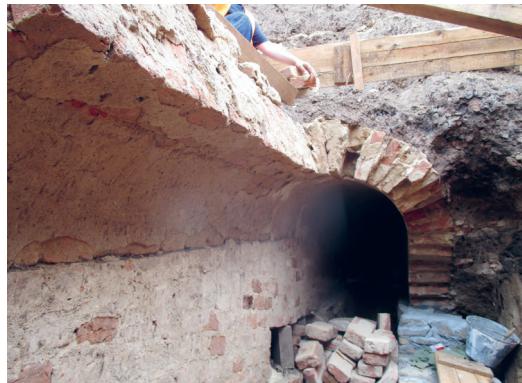
Galleries are susceptible to pressure fluctuations from various external factors, leading to recurring defects that can result in structural collapse – repair of a **level 1 mine branches** following the 2013 floods (J. Hofman).

Last but not least, there is a lack of regular and systematic maintenance by the owner, who should continuously replenish fallen bricks, re-grout the necessary sections, monitor the extent and development of defects, limit recent, uncontrolled entrances to the galleries (e.g. sewer drains or foundation structures), remove vegetation root systems, remove collapsed parts of niches and repair them with suitable new materials, and fulfil the function of floor spacers and stabilisation layers. It is also essential to create a detailed asset registry of the entire system and a subsequent schedule of regular maintenance and planned repairs.
